Ridge Preservation using Porcine Xenograft and dPTFE Membrane

Gustavo Avila-Ortiz, DDS, MS, PhD

Chris Barwacz, DDS, FAGD

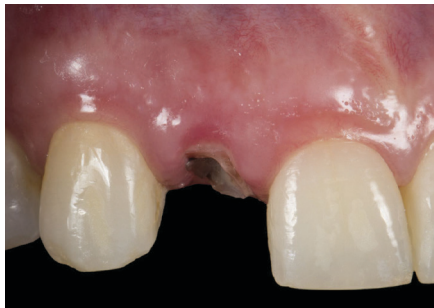
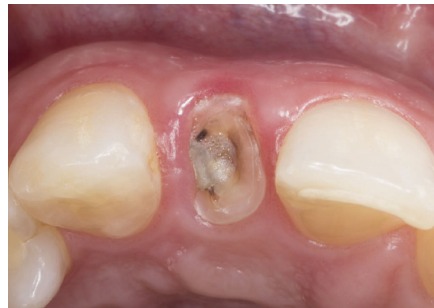
A 47-year old female with no contributory medical history presented with a cervical tooth fracture on the right maxillary lateral incisor (Fig 1a & 1b). A thorough clinical examination was conducted. All periodontal parameters were normal, except for BOP on the mid-facial. Plaque control was adequate. A CBCT scan and a periapical radiograph indicated normal interproximal bone levels, and the thickness of the buccal bone ranged from 0.6 to 0.9 mm (Fig 2a & 2b). Different treatment options were considered, including tooth conservation and tooth-supported FPD, but patient opted for tooth replacement with an implant-supported prosthesis.

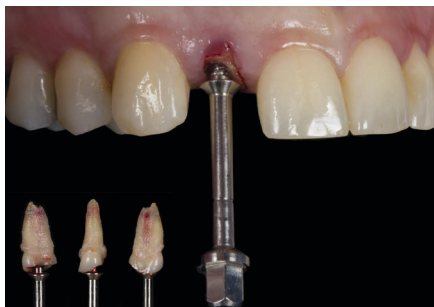
Fig 3

The remaining tooth structure was extracted in a minimally invasive fashion to avoid damage to the supporting hard and soft tissue structures (Fig 3). Following meticulous debridement and irrigation of the socket, subperiosteal pockets were created on the buccal and lingual aspects of the alveolar ridge. A dPTFE (dense polytetrafluoroethylene) membrane (Cytoplast™ TXT Singles) was gently tucked into the buccal pocket and porcine-derived cancellous xenograft particles (Zcore™) were placed in the socket, up to the level of the crestal bone (Fig 4). The dPTFE membrane was then tucked into the lingual pocket and a horizontal cross mattress suturing technique using PTFE suture (Cytoplast™ PTFE Suture 4-0) was placed to secure the membrane and stabilize the soft tissue margins (Fig 5). The application of a dPTFE membrane allows for a conservative regenerative approach that does not require primary closure via buccal flap advancement. Immediately following this ridge preservation procedure, a periapical radiograph was taken to verify that the xenograft particles were level with the crestal bone (Fig 6). Before dismissal, patient was instructed to clean the exposed membrane area by carefully swabbing twice daily with a cotton pellet soaked in Chlorhexidine 0.12% aqueous solution.

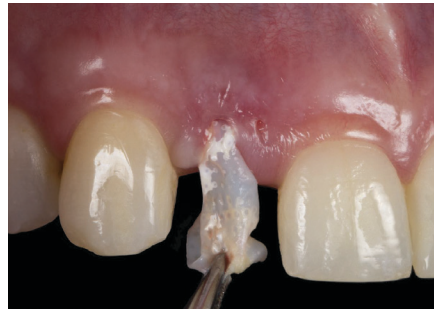
Fig 8a

At 6 weeks, the membrane was removed using tissue forceps (Fig 8a). Upon clinical examination, the soft tissue architecture had remained intact. Slight bleeding could be observed around the perimeter of the wound and in the area immediately underlying the membrane, which is normal (Fig 8b).

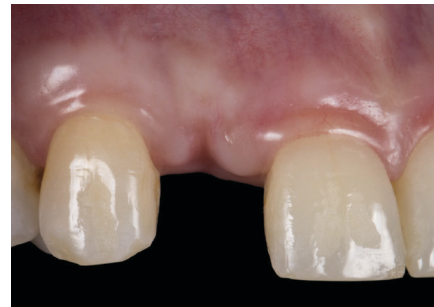
Fig 9

At 12 weeks, the soft tissue appears mature and a supracrestal increase in the band of keratinized tissue was visible. Esthetics of the anterior ridge have been preserved at an optimal level (Fig 9).

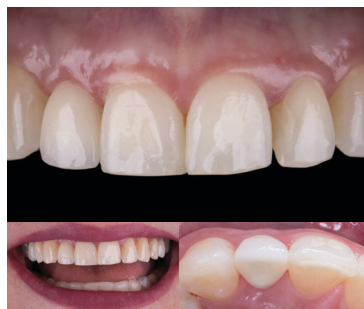
Fig 14

The final single-tooth implant crown was delivered at 10 weeks after implant placement using a custom zirconia abutment that was hand-layered with porcelain. A natural emergence profile and a very satisfactory esthetic and functional outcome was achieved (Fig 14). A periapical radiograph was taken to verify the maintenance of normal marginal bone levels and absence of pathosis (Fig 15).
